AGARD REPORT 785

The Utilization of Advanced Composites in Military Aircraft

*Papers presented at the 73rd Meeting of the AGARD Structures and Materials Panel,
held in San Diego, CA, United States, 7th-11th October 1991.*

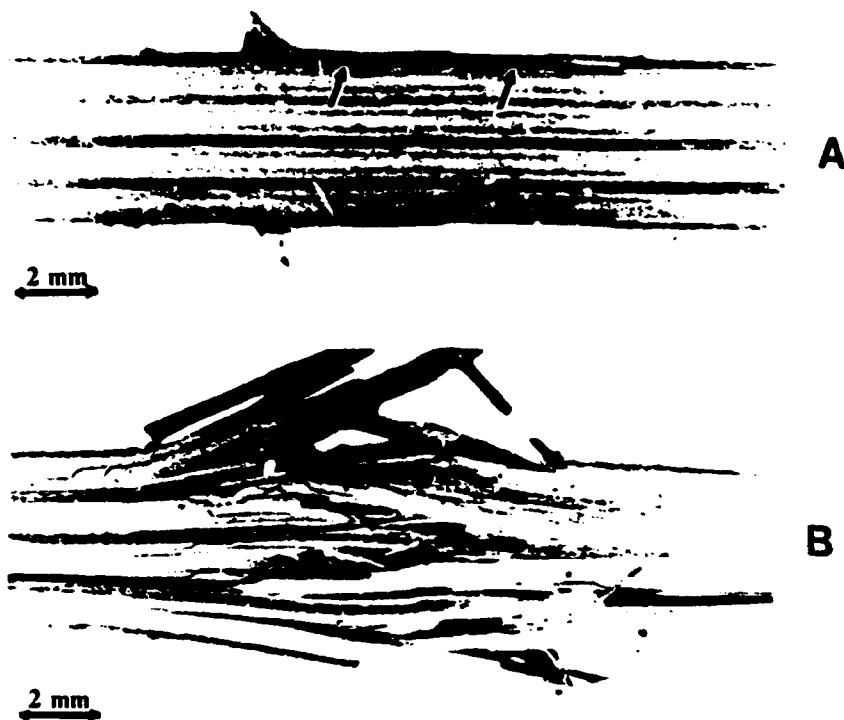
FIGURE 17. Edge views of the gage sections of $[0/\pm 45/90]$ AS4/3501-6 all-laminate coupons tested in axial compression : (A) after initial failure via delamination of outer 0° and 45° plies; (B) after final failure.

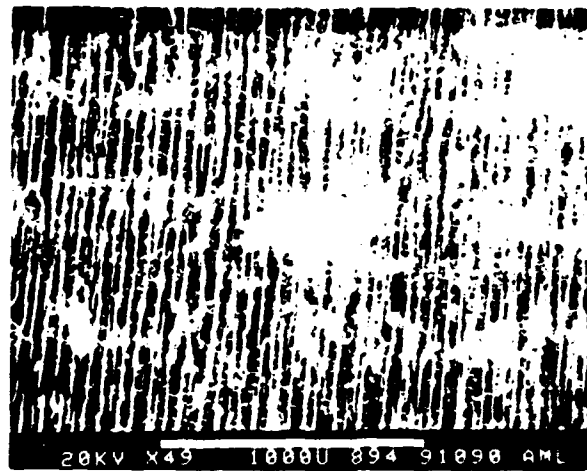
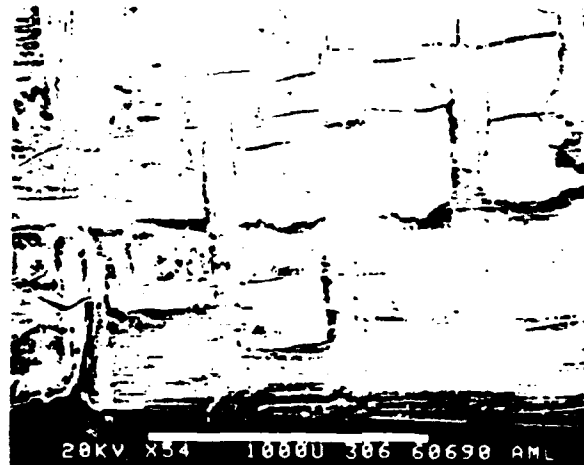
Figure 3 Electron micrographs of degraded surface

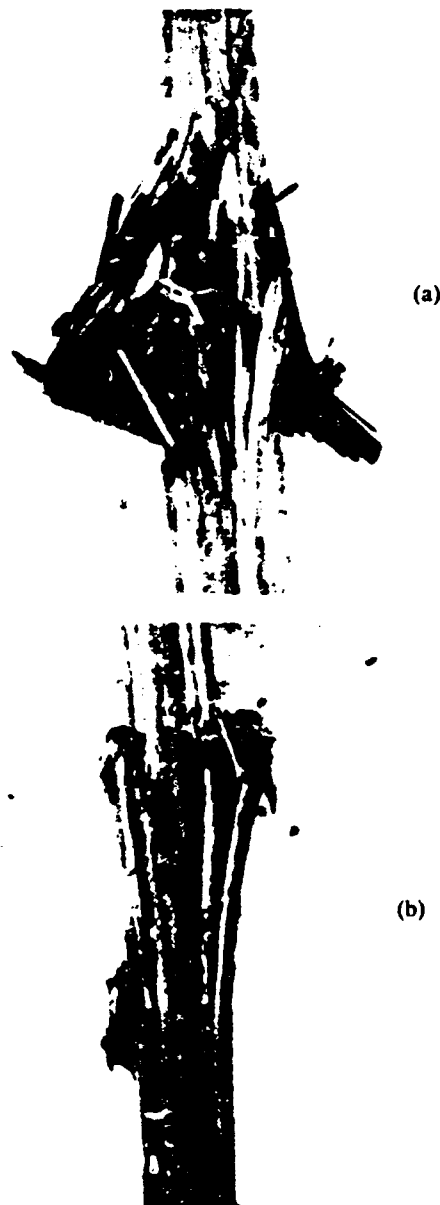
Figure 5. Edge Views of Failed Specimens (a) DR (b) MH (x25)

Compression micro-buckling appears to be the primary failure mechanism for these specimens; it involves local buckling of

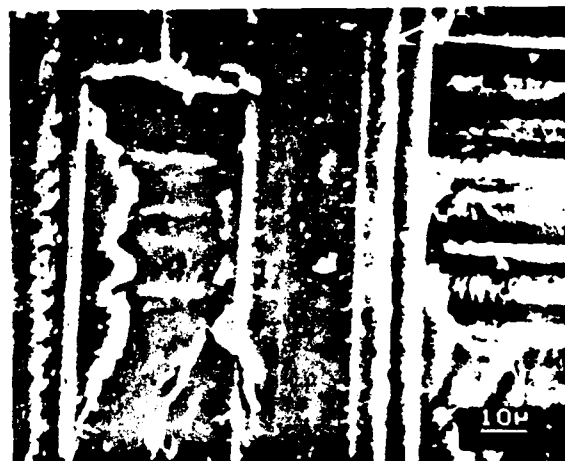
Figure 9. Fracture Surfaces of DH Specimen Between 0° and 90° Cross-ply

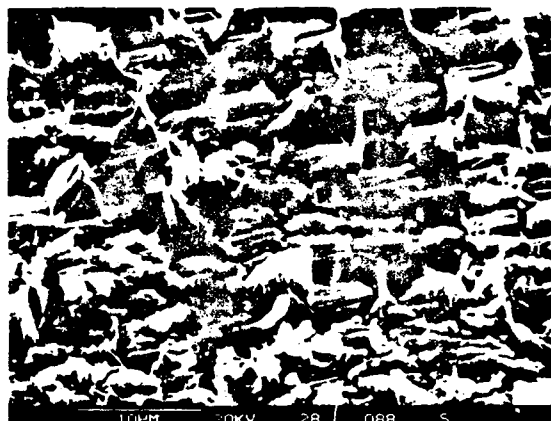
Figure 8. Compressive fibre failure and ductile tensile failure of the matrix of APC2-FC(330).

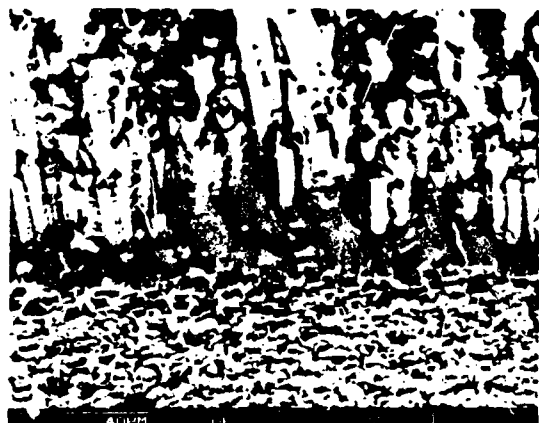
Figure 9. Fibre-matrix interfaces in tension area and fibre tips in compression area (APC2-FC(330)).
